**PRELIMINARY ASSESSMENT/  
VISUAL SITE INSPECTION**

**ACME FINISHING COMPANY, INC.  
ELK GROVE VILLAGE, ILLINOIS**

**FINAL REPORT**

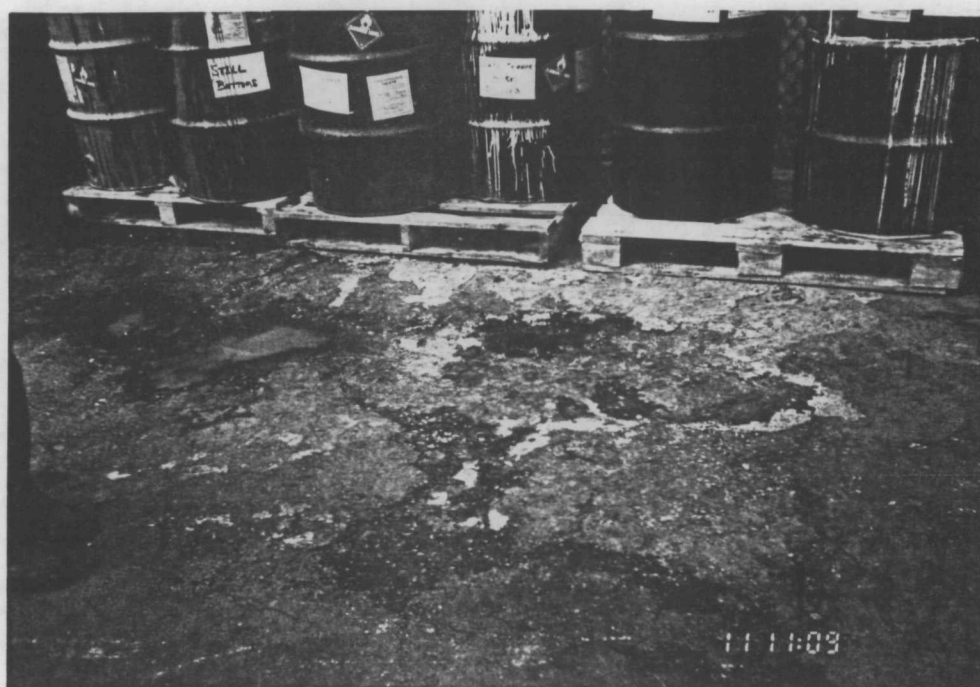
**Photograph No. 7**

During the VSI, evidence of releases from two areas was observed. The asphalt floor of the Outdoor Drum Storage Area (SWMU 1) had white staining and was pitted and cracked in places (Photo 7). This may indicate releases of small quantities of material from the drums stored there. However, it appeared that such releases were contained in the immediate vicinity and thus posed no threat to the environment. In addition, the wall and ground adjacent to the Outside Paint Solvent Fill Ports (AOC 1) was stained, indicating small spills during filling of the tanks. Again, these releases appear to have been well contained.

**Observations:** The asphalt paving in the storage area shows evidence of age in the form of cracks and pits (Photos 7 and 8), and there is evidence of small releases, as outlined above.

**Conclusions:**                      This area has no secondary containment, and the concrete floor is cracked and pitted (Photo 7). For these reasons, the potential for release to ground water, surface water, air, or soil is moderate.

**Description:** Close-up view of asphalt flooring in front of hazardous waste drums. In spite of evidence of wear, integrity intact.

**Location:** SWMU 1

**Recommendations:**              Conduct soil sampling beneath the stained areas of the asphalt. Provide adequate secondary containment, preferably in the form of a berm around the area.
